Bio-Bead pollution on our beaches

**A Cornish Plastic Pollution Coalition report
Second edition, July 2018**

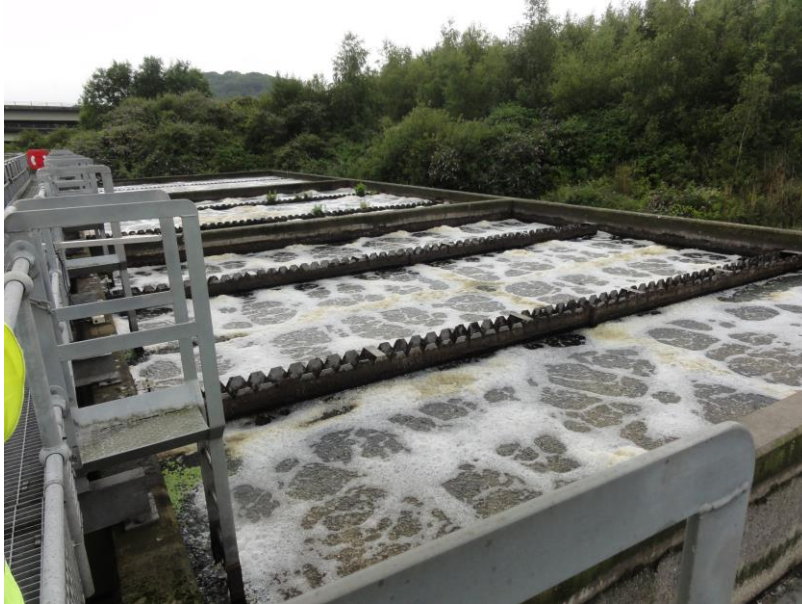
View of reactors in operation, from above (SWW Plympton plant, June 2017). Water bubbles up through the Bio-Bead bed, then through the steel mesh above it, before running down the raised channels, visible above the tanks, to the outflow.

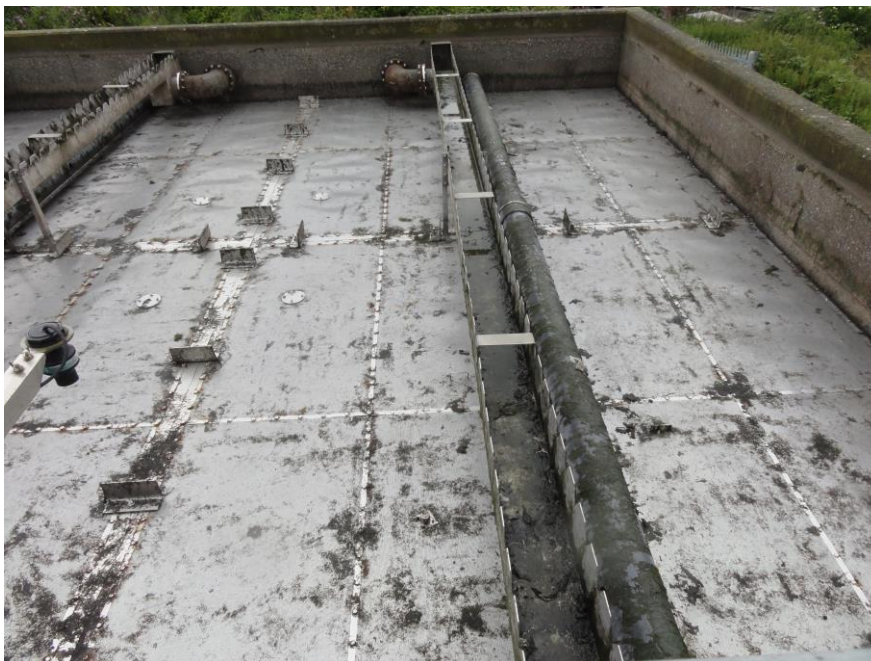
Image of an empty tank (SWW Plympton plant, June 2017), showing the position of the steel mesh screen in the reactors.

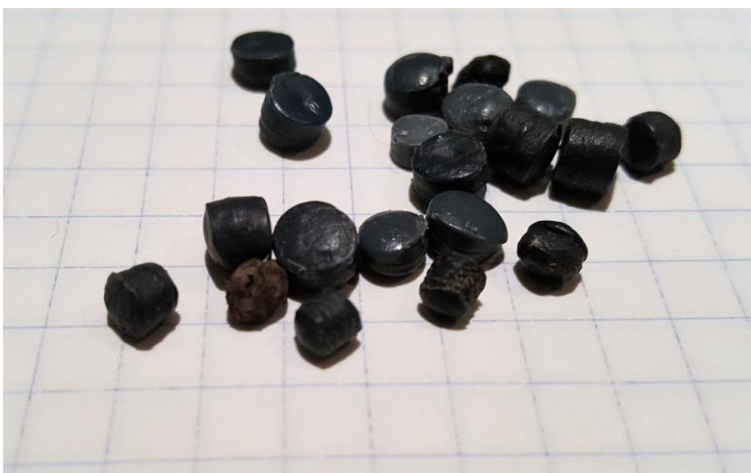
Pellets found by kayaker Mary James along a small area of riverbank on the Truro River at Malpas on February 18, 2018

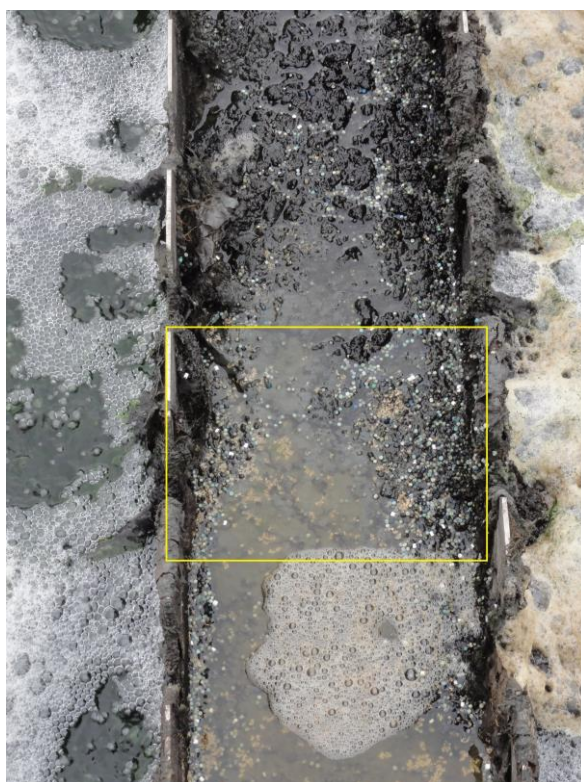
Source of some losses? Bio-Beads visible in the channel of treated water above a BAFF reactor at Plympton in June 2017 (image below is a close-up of the marked section at left). Water travels from these channels straight to the outfall and into the River Plym.

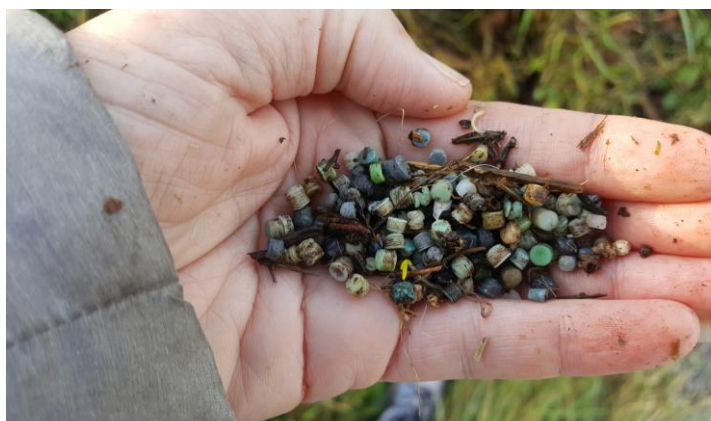
Above: 249 Bio-Beads found in a 50cm² area of riverbank downstream from the Plympton plant at the Blagdon's Meadow County Wildlife Site. Some beads were lying on the surface of vegetation, others were buried right down into the sediment, apparently having been there for a long time.

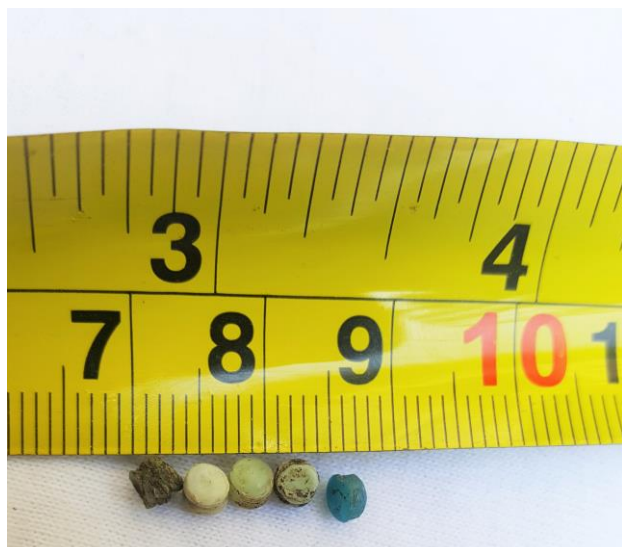
Some pellets collected from the South West Water plant at Plympton in January 2017 seem to measure only just 3mm – the same width as the holes in the screen over the top of the BAFF reactors. The fact that they still have their original ridging suggests that abrasion is not the cause. Picture: Claire Wallerstein

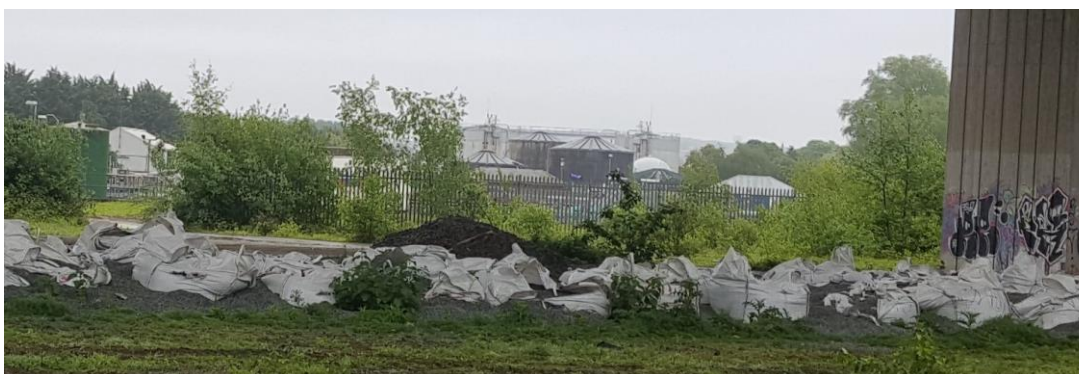
Bio-Beads spilling out of open dumpy sacks in the SWW storage area near the Plympton plant.

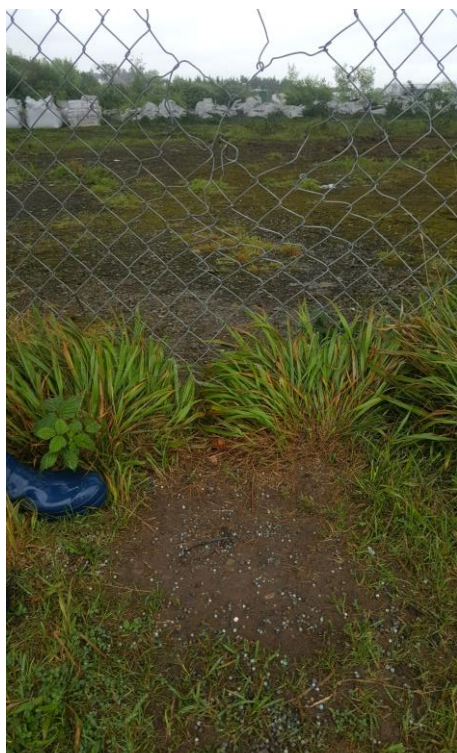
Left: A hole through the fence to the SWW storage area along the public footpath adjoining the Plympton plant site, dumpy sacks visible in the background, Bio-Beads in the foreground , 17 May 2017 (Claire Wallerstein)

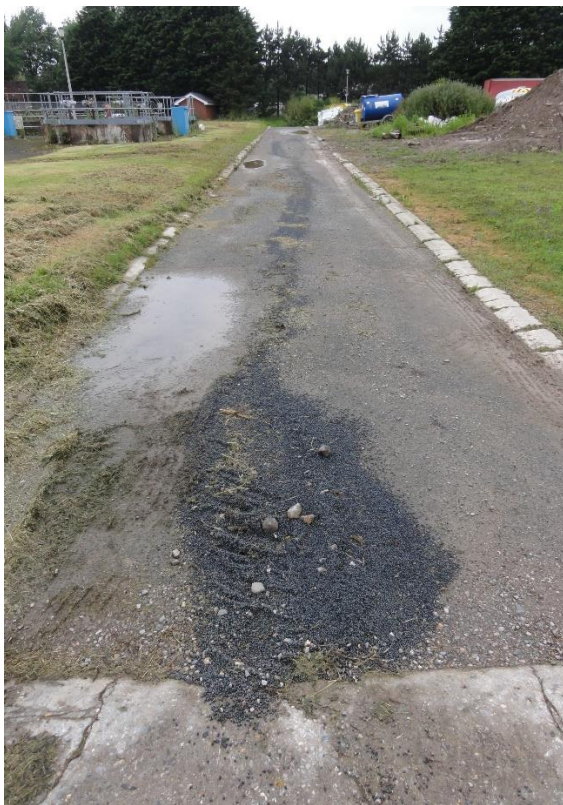
Trail of black Bio-Beads spilled along the length of a road within the Plympton site, following removal of the vandalised sacks of beads to a more secure location, June 2017

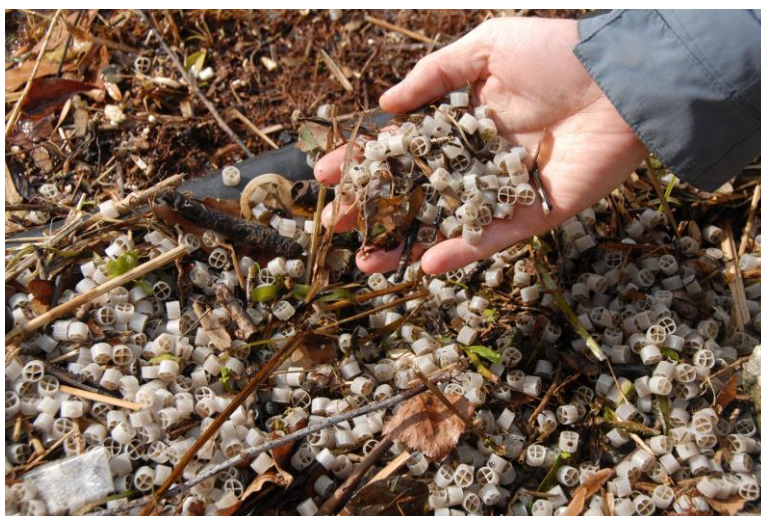
Another type of biomedica, this one wheel shaped, commonly used in wastewater treatment in the UK as well as elsewhere. This image is from a spill in Corbeil Essonne (near Paris) in February 2010 when a municipal wastewater treatment plant lost 800m3 of biomedica into the river Seine.

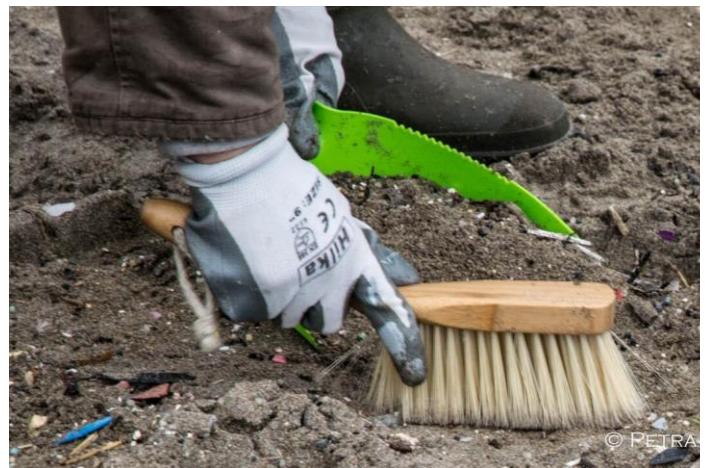
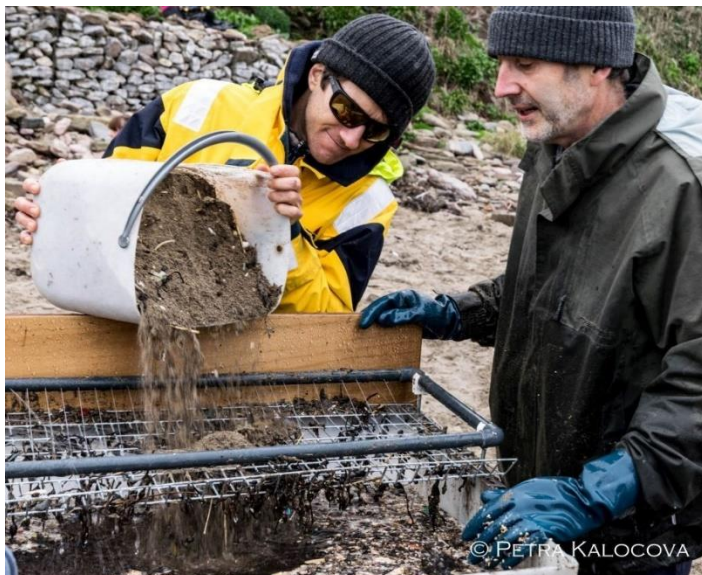
Using the machine to separate microplastics, including Bio-Beads, from the sand, March 2017
